**ROYAL
AERONAUTICAL
SOCIETY**

SMOKE, FIRE AND FUMES IN TRANSPORT AIRCRAFT

PAST HISTORY, CURRENT RISK AND RECOMMENDED MITIGATIONS

**Second Edition 2013
Part 1: Reference**

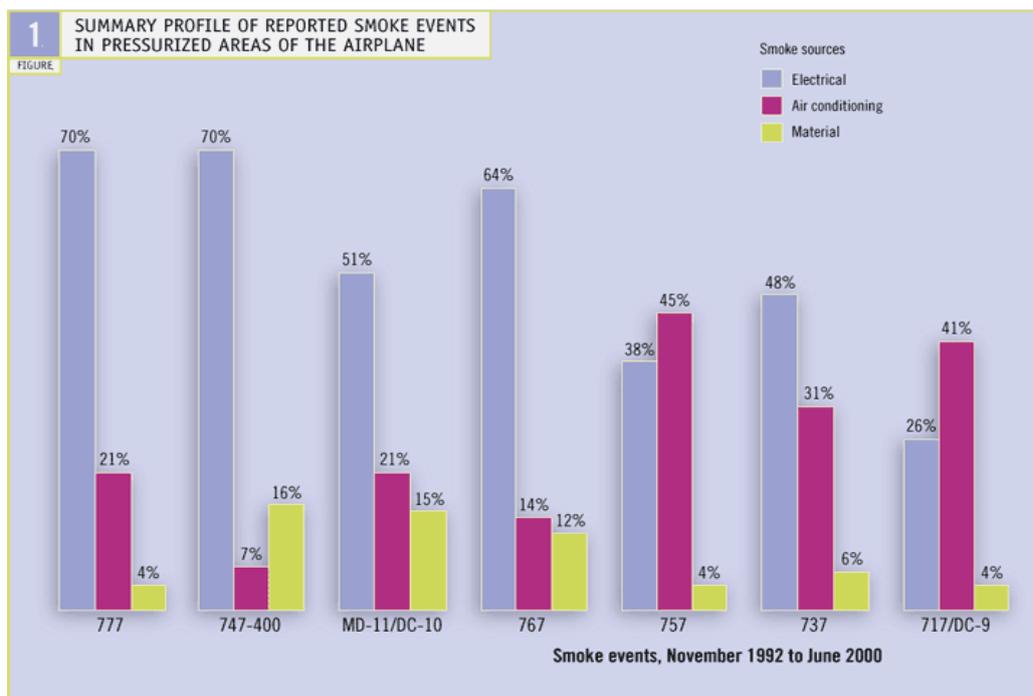
The figure below shows some causes of smoke by aircraft type

(Fleece, 2003)

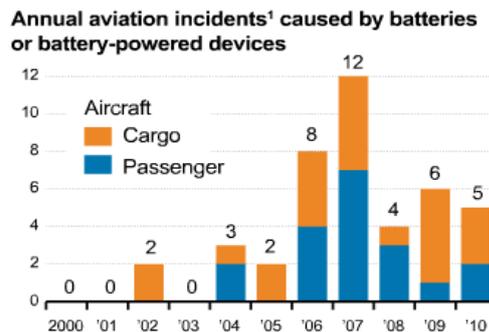
Battery Cargo in Planes

1 – Incidents involving smoke, fire, extreme heat or explosion

Source: Federal Aviation Administration, Transport Canada and England's Civil Aviation Authority

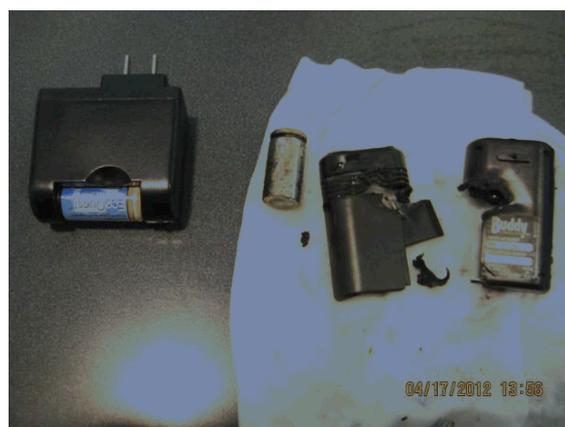
Figure 1. Photo of Mini Air Purifying Device after lithium-ion battery fire on flight from Toronto, Canada, to Minneapolis/Saint Paul, Minnesota, 17 April 2012.

Batteries travelling in passenger baggage can also start an in-flight fire. The FAA recommends that lithium batteries should not be packed in checked luggage, but kept in hand luggage and stowed in overhead aeroplane's compartments during flight. On 17 April 2012, an in-flight battery fire incident occurred on Pinnacle Flight 4290 from Toronto, Canada to Minneapolis/Saint Paul, Minnesota (LitBat Fire TransCanada October 2011). While at 28,000ft, a passenger's personal electronic device (an air purifier) caught fire.

During the in-flight service, the flight attendant noted that the device was on fire on the floor; its battery was burning several feet from the device. Using water from the

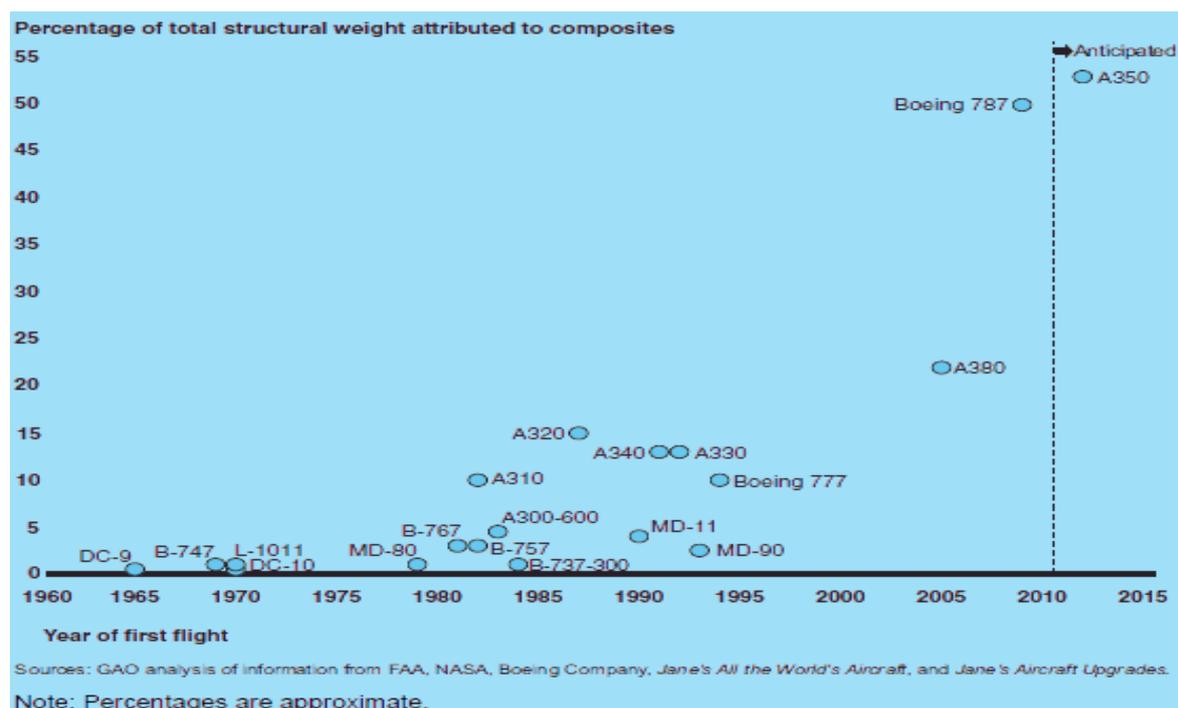
The following Figure shows the percentage of total structural weight attributed to composite materials used in aeroplane construction since the mid-1980s:

(United States Government General Accountability Office, 2011)
