Aeroplane Upset Recovery Training

History, Core Concepts & Mitigation

A Specialist Paper by the Royal Aeronautical Society
October 2010

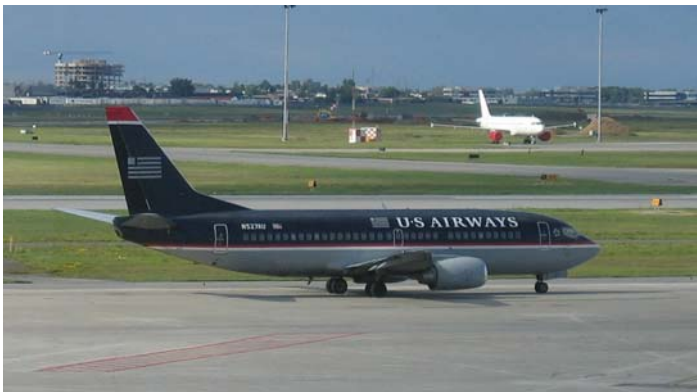
1.1 USAir 427

Had the Rudder PCU not been defective thus causing a hard-over deflection of the control surface, this upset might have been recoverable. In the circumstances, it was not.

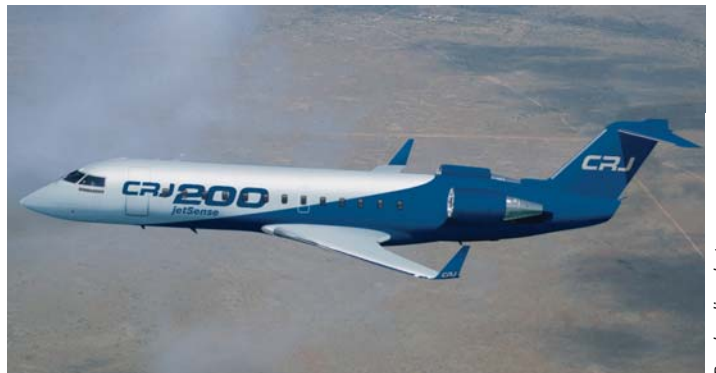
1.3 Pinnacle Airlines Flight 3701

Bombardier photo.
