**ROYAL
AERONAUTICAL
SOCIETY**

SMOKE, FIRE AND FUMES IN TRANSPORT AIRCRAFT

PAST HISTORY, CURRENT RISKS AND RECOMMENDED MITIGATIONS

Part 1: Reference

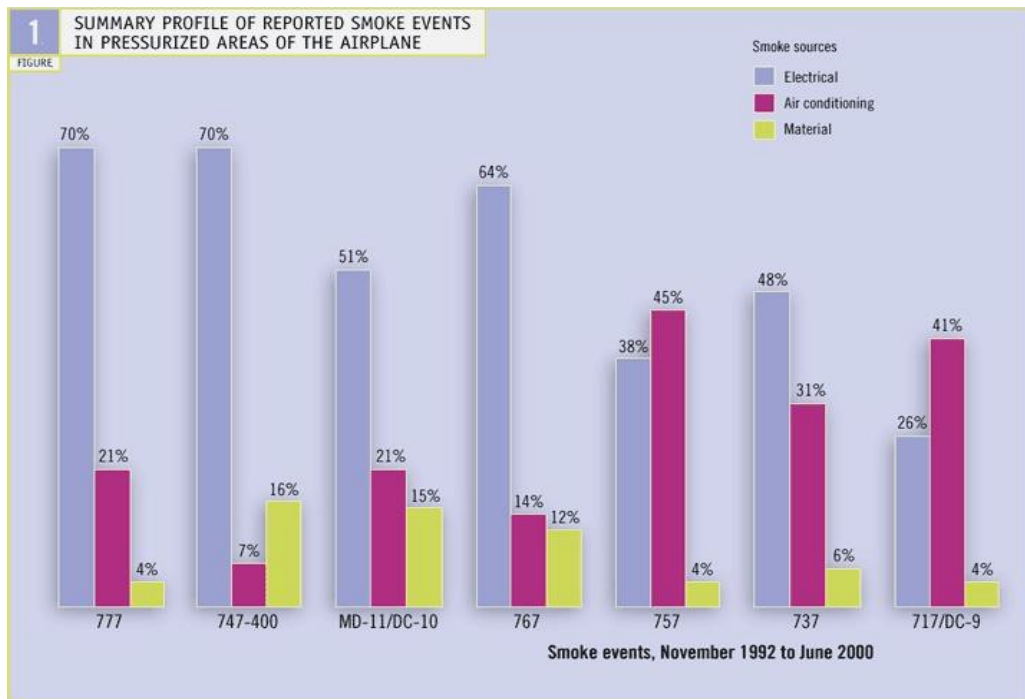
The most frequent source of fire in transport aeroplanes is electrical. A Boeing study showed that between November 1992 and June 2000 that over two thirds of the in-flight fires on Boeing aeroplanes were electrical (Boeing, 2000). One major ignition source for electrical

fires is aeroplane wiring. In modern large transport aeroplanes there are over 500,000ft (150km) of wire. (Potter, 2003)

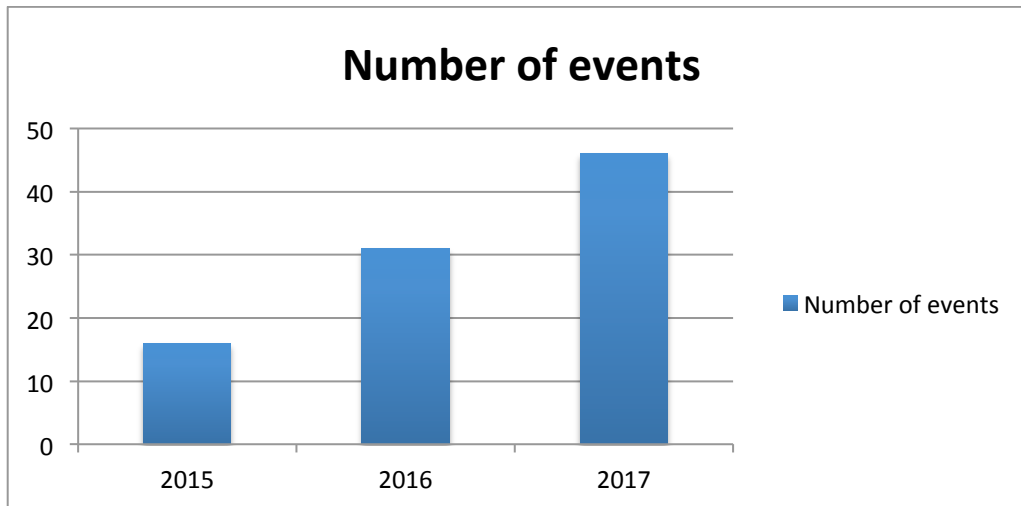
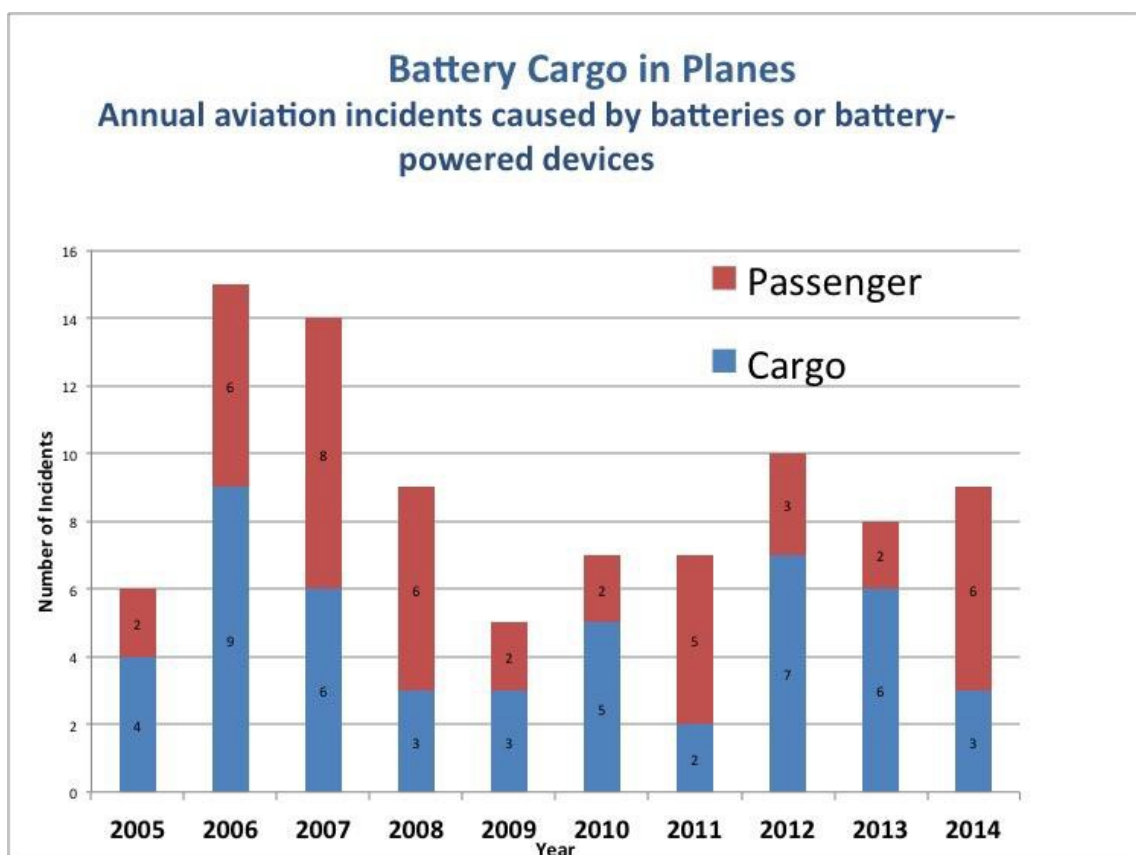
One of the largest trends in the growth of in-flight fires is due to the transportation of lithium batteries. From March 1991 to August 2018, the FAA office of Security and Hazardous Materials Safety recorded 225 cases of aviation incidents involving smoke, fire, extreme heat or explosion involving batteries and battery powered devices (FAA, 2018). Lithium batteries were the majority of battery types in the incidents. Of particular concern is the increasing number of lithium battery fires onboard aeroplanes. In 2018 between January and August there were 34 events, in 2017 there were 46 events, in 2016 there were 31, and in 2015 there were 16 (FAA 2018).

(FAA, 2015)

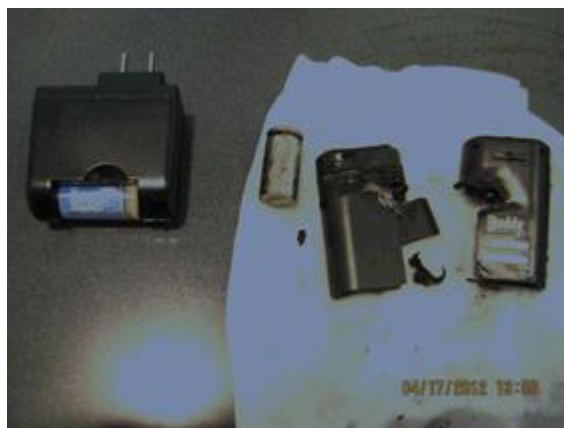
Photo of Mini Air Purifying Device after lithium-ion battery fire on flight from Toronto, Canada, to Minneapolis/Saint Paul, Minnesota, 17 April 2012.

During the in-flight service, the cabin crew noted that the device was on fire on the floor; its battery was burning several feet from the device. Using water from the service cart, the cabin crew put out the fire using wet paper towels. One of the cabin crew then submerged the battery in a cup of water because the battery was still smouldering. On the flight deck, the captain sensed a very strong burning electrical odour coming from the cabin. An emergency was declared and the flight diverted and landed safely at Traverse City, Michigan.

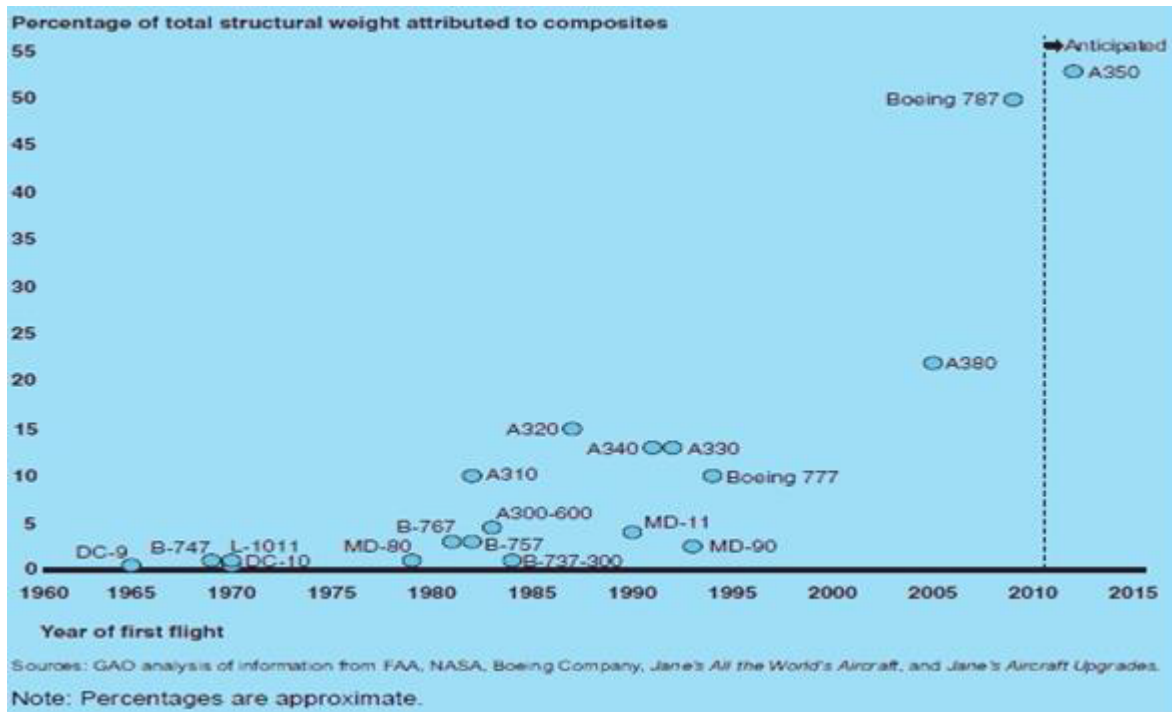
The following figure shows the percentage of total structural weight attributed to composite materials used in aeroplane construction since the mid-1980s:

(United States Government General Accountability Office, 2011)
